# Navajo Abandoned Uranium Mine

## **Site Screen Report**

### Charles Huskon No. 14 AUM Site

January 2011

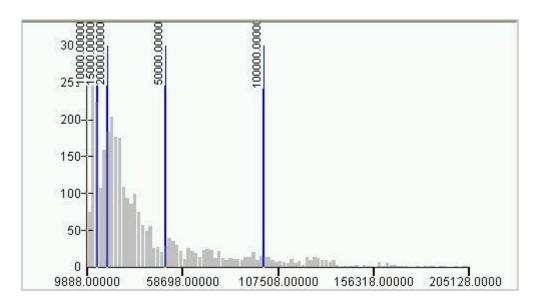
The following chart and statistics were generated by ESRI ArcGIS 9.3.1, and show the general distribution of the site gamma radiation measurements. The horizontal X axis represents the gamma radiation reading levels in cpm (lowest levels to the left). The vertical Y axis represents the frequency of each gamma radiation level.

Count:	3003
Minimum:	9888.00000
Maximum:	205128.00000
Sum:	117571426.00000
Mean:	39151.32401
Median:	26398.00000
Standard Deviation:	32688.01393

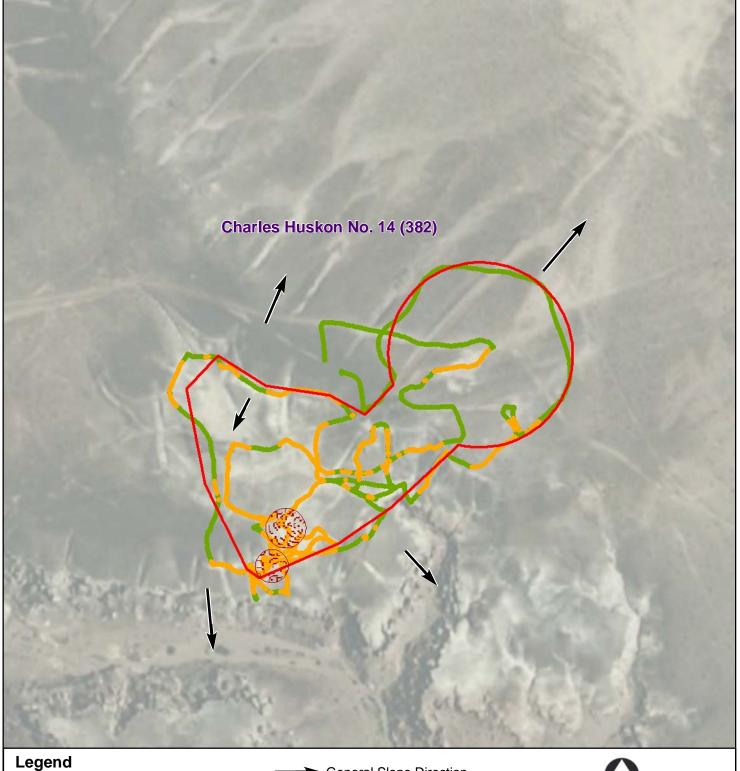
Figure 1 - Gamma Radiation Measurements, Above Two Times Background
Charles Huskon No. 14 (382)
Cameron Chapter, Navajo Nation

A total of 3,003 gamma radiation measurements were collected from the mine site, ranging from 9,888 cpm to 205,128 cpm. The measurements collected at the waste piles were found at maximum levels ranging from approximately 110,000 cpm to 200,000 cpm, and at background levels at the structure. The measurements are represented in Figures 1 and 2.

Average background 12,567 cpm

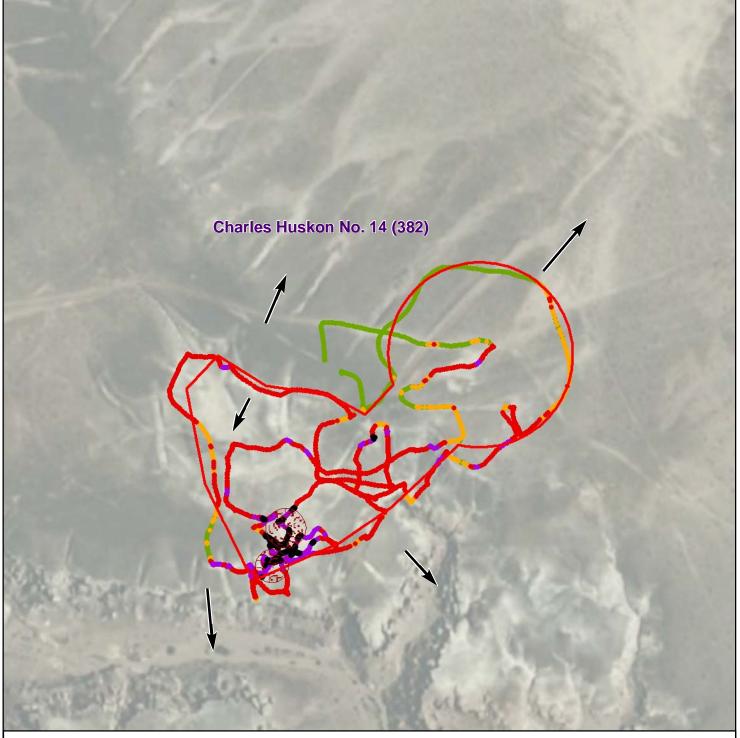
Figure 2 - Gamma Radiation Measurements Charles Huskon No. 14 (382) Cameron Chapter, Navajo Nation

Average background 12,567 cpm
